## WINDSHIELD GLASS – APPLICATIONS IN AUTOMOBILE ACCIDENT FORENSICS

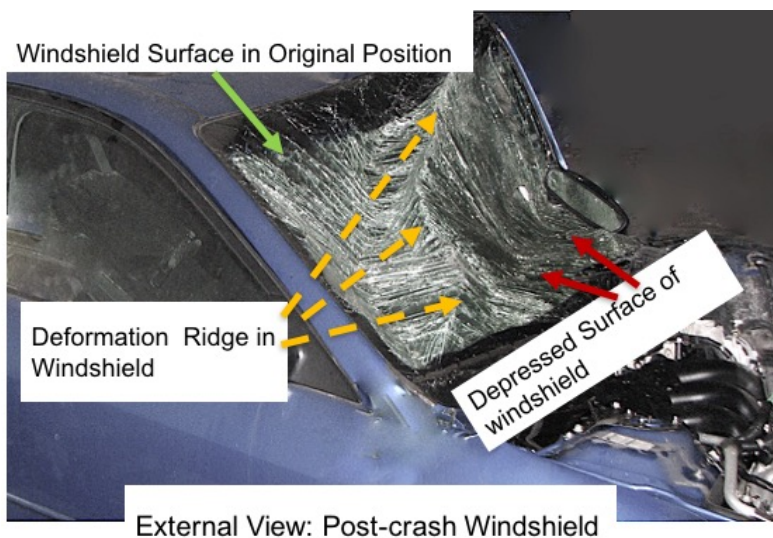
The prominent ('global') damage in the post-crash windshield is observed to be a diagonal 'ridge' extending from the bottom of the passenger-side A-pillar to the top of the driver-side A-pillar. This

ridge deviates from an almost straight line shape in the vicinity of the passenger-side pillar. Multiple fracture lines are observed on each side of the ridge. Several other observations can also be made: (a) the surface of the windshield near the top of the passenger-side pillar remains undisturbed; and (b) the

severe deformation of the windshield in the vicinity of the bottom of

driver-side pillar makes its surface parallel to the dashboard surface. The multiple impacts to the windshield in this case divide it into 'segments', each segment containing some information about the parameters of the accident. Highly detailed photographs of each segment were evaluated for variables such as: the density and orientations of fracture lines; the change in the shape of these lines as they cross the 'ridge'; slopes and dimensions of various segments, etc. One example conclusion is that the impact leading to the 'ridge' was preceded by fracture lines formed in one segment.

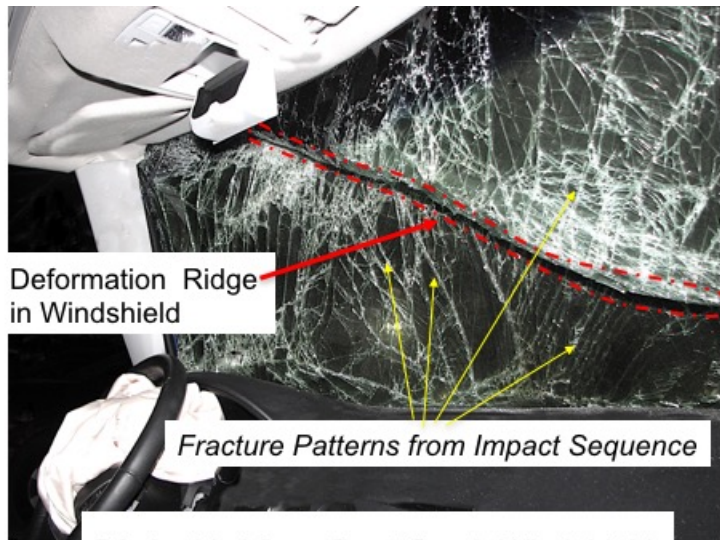
P2: Inside View: Post-Crash Windshield

photograph and the one shown above, this photograph P2 contains additional details of the windshield's fracture patterns and these were analyzed from suitably enlarged views of each section of the windshield.

When examined closely with proper magnification, the photograph 'P2' also shows an impact to the inner surface of the windshield. For the actual case, each part of the damaged windshield was photographed separately in high resolution. This technique

established that the fracture pattern from impact on the inner layer of glass corresponded to the driver's head hitting the windshield. It also established the timing of this impact in the multi-impact sequence.

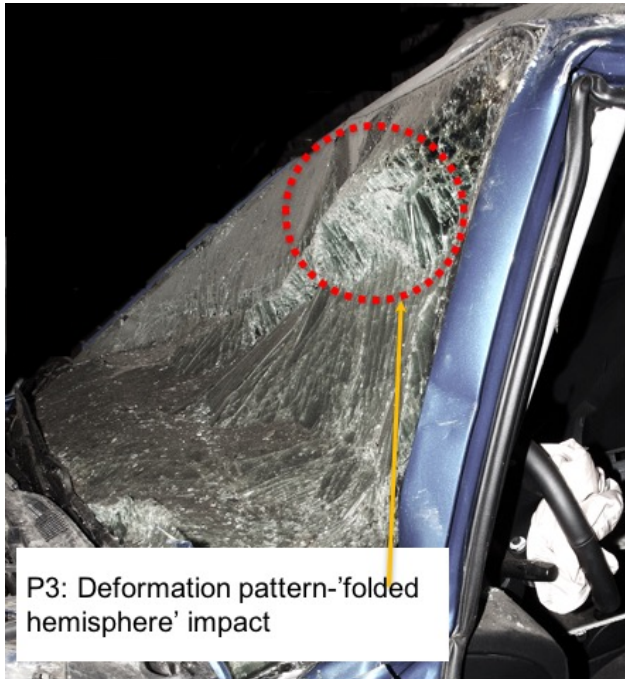
P3: Deformation pattern-'folded hemisphere' impact

many details of the accident. A visual observation shows the 'bulge' in the windshield from the inside of the car in the outward direction. Analysis of the superimposed damage patterns sequences this interior impact as following the formation of the diagonal ridge but preceding some of the other damage segments in the windshield.

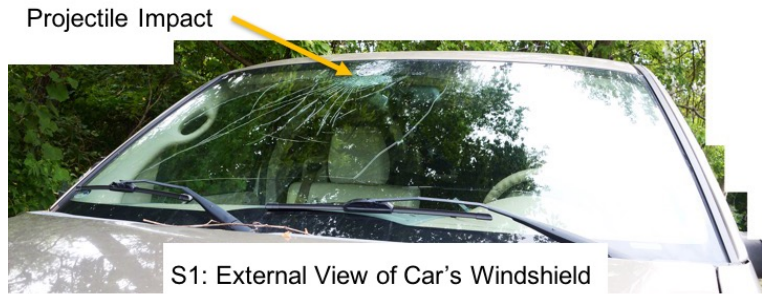
The overall view of the vehicle in the photograph 'S1' here shows the impact to be near the top surface and in the center of the windshield

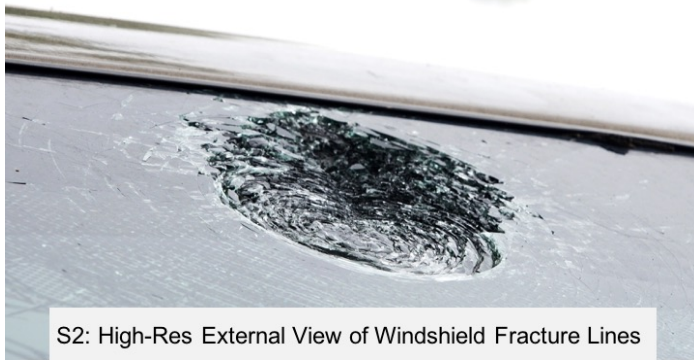
The photograph 'S2' is a high-res exterior view of the impact 'crater'. This and other similar photographs from different angles and

viewpoints were analyzed for the relative depths of various points in the crater. This information, combined with the known shape of the impacting object helped determine the orientation of the projectile when it hit the windshield. Since the broken

glass fragments were retained by the PVB layer of the windshield, it was also possible to evaluate the orientation of the glass fragments inside the indentation, thus providing more information to help determine the direction of impact.

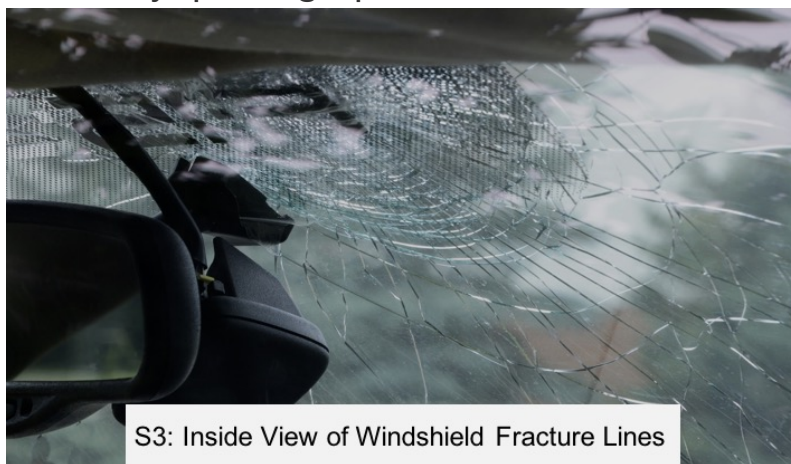
Similarly, photographs taken from other viewpoints, e.g. from inside

the vehicle as in 'S3', show fracture propagation patterns in the laminated glass. Analyses of the shape, density and dimensions of these fractures (or 'cracks in glass') also help determine, to some extent, the direction of

the force at the moment of impact.
