Photo Audit of Furniture Retail Store Columbus Blvd, Philadelphia PA

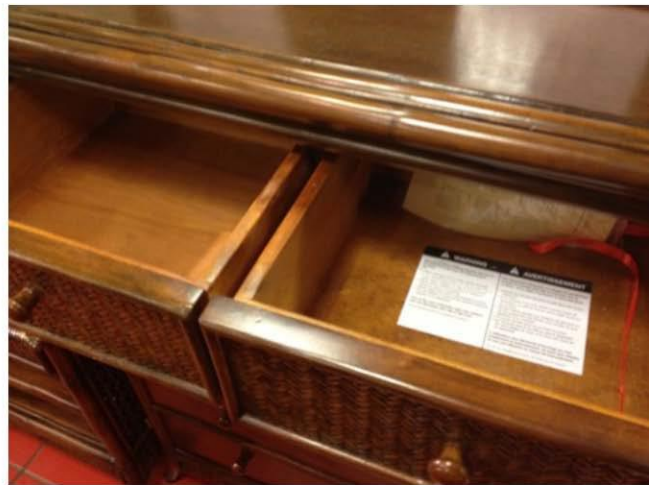
Warning label inside drawer

During my examination of the store and in particular the Ashworth Chest I opened the drawers to see if there was any binding that might have caused the chest to tip forward when pulling on the knobs. Not having the actual sample to review from the accident, based on what I observed, a warning label in the top right drawer warning of the potential that this piece of furniture could tip over (see below photo of label). I do not know if this label was part of the original chest that was involved with the accident.

This warning is ineffective for several reasons. First it should be posted by the store on top of the unit or on the price label so the warning is read prior to sampling the unit. It is not unreasonable to assume a person could open two drawers at one time as warned against doing. It is not unreasonable that this drawer with the warning is actually not the one selected when a customer is trying the opening process of a drawer. It states "or heavy object" with no reference to an approximate weight which creates ambiguity. It states to use a tip-over restraint yet the store does not follow this practice when placing the sample unit on the floor.

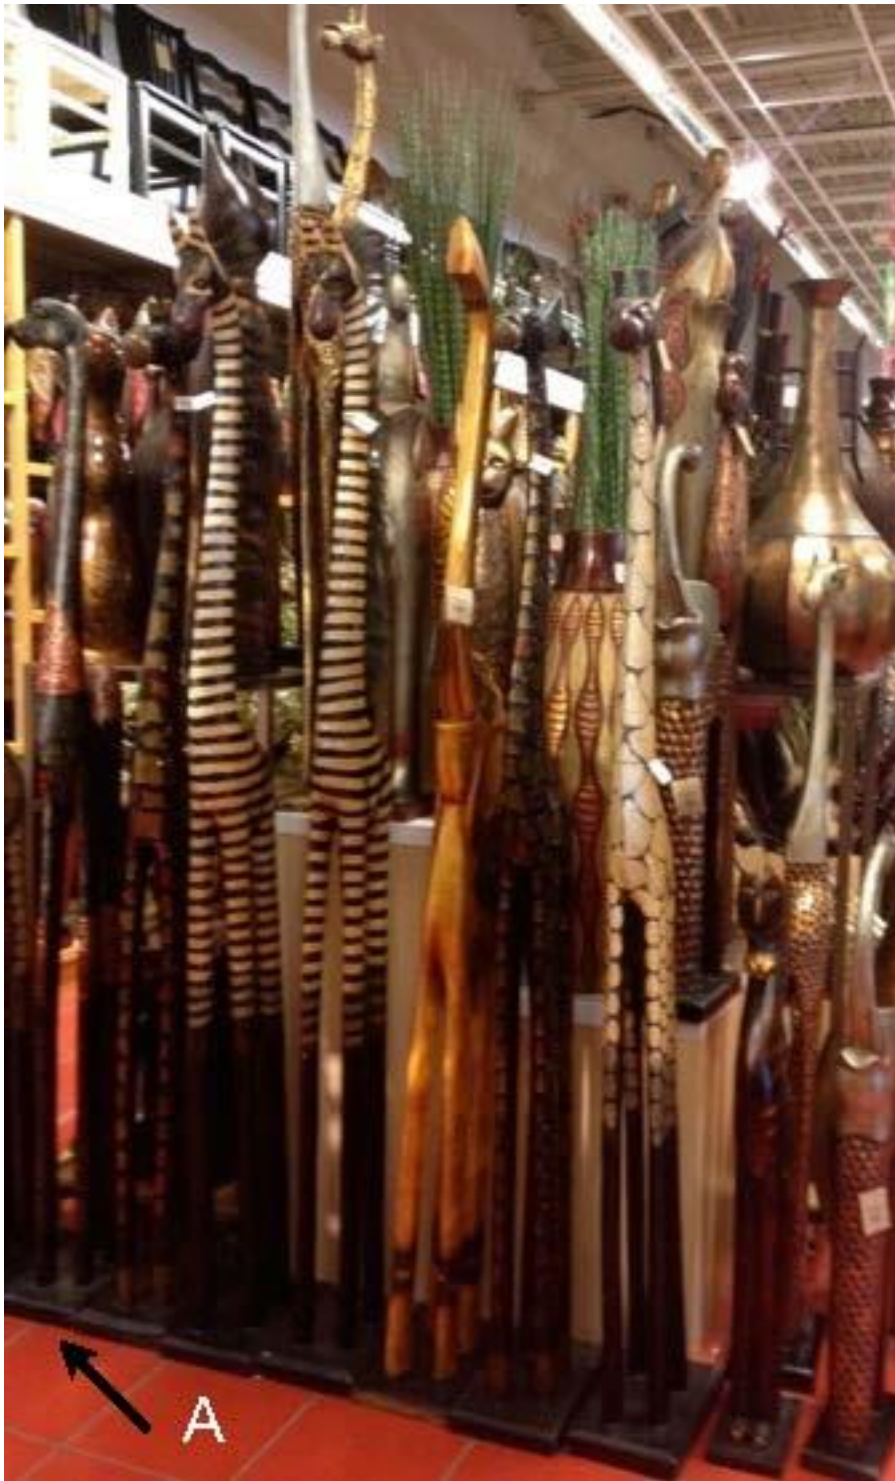
A. This area reserved for standing animal figures is a good way to show an item this high. To place these figures on top of a piece of furniture would not benefit the visual presentation as the overall height would not simulate what one would do in reality in their home. These figures are thin and tall which makes the stability of the item if placed on a flat surface a concerning issue. Due to the geometry of the statue, a pendulum reaction would occur should the base start to rock as a result of the piece they are standing on is set into motion by a nudge, or pulling a draw.

B. You can see by the illustration below that the taller the item, the greater the distance it travels at the top.

This action increases the likelihood of the item tipping over due to the height.

Tipping exaggerated due to height

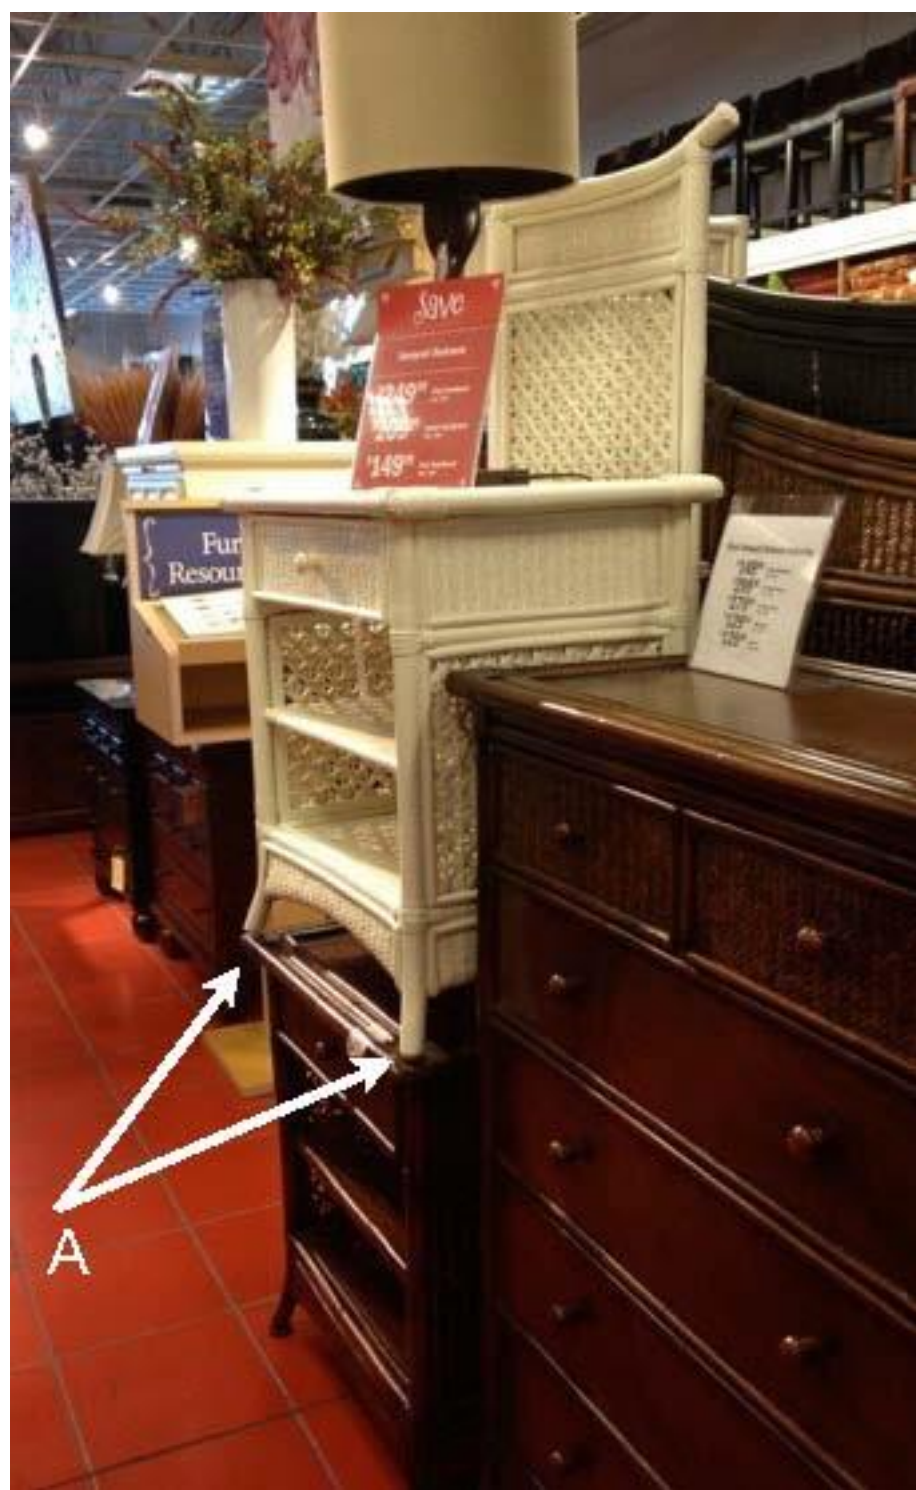
A. This condition is a blatant statement that Furniture Retail Store tolerates a dangerous condition to exist in a store and not take immediate action to resolve. The store manager should be looking out for conditions such as this table on the edge of the surface below it. The table needs all four leg point of contact to be secure or the table will fall. The lamp on the table adds additional liability issues which are allowed to exist. In my opinion, based on the fact that I cannot review prior conditions that led up to the accident is

that the same mentality and store discipline that exists today were in effect at the time of the accident. Certainly if I was a manager and I know there was a critical accident in the past that was due to an object falling off a surface I would make every attempt to make my store as accident proof as possible.

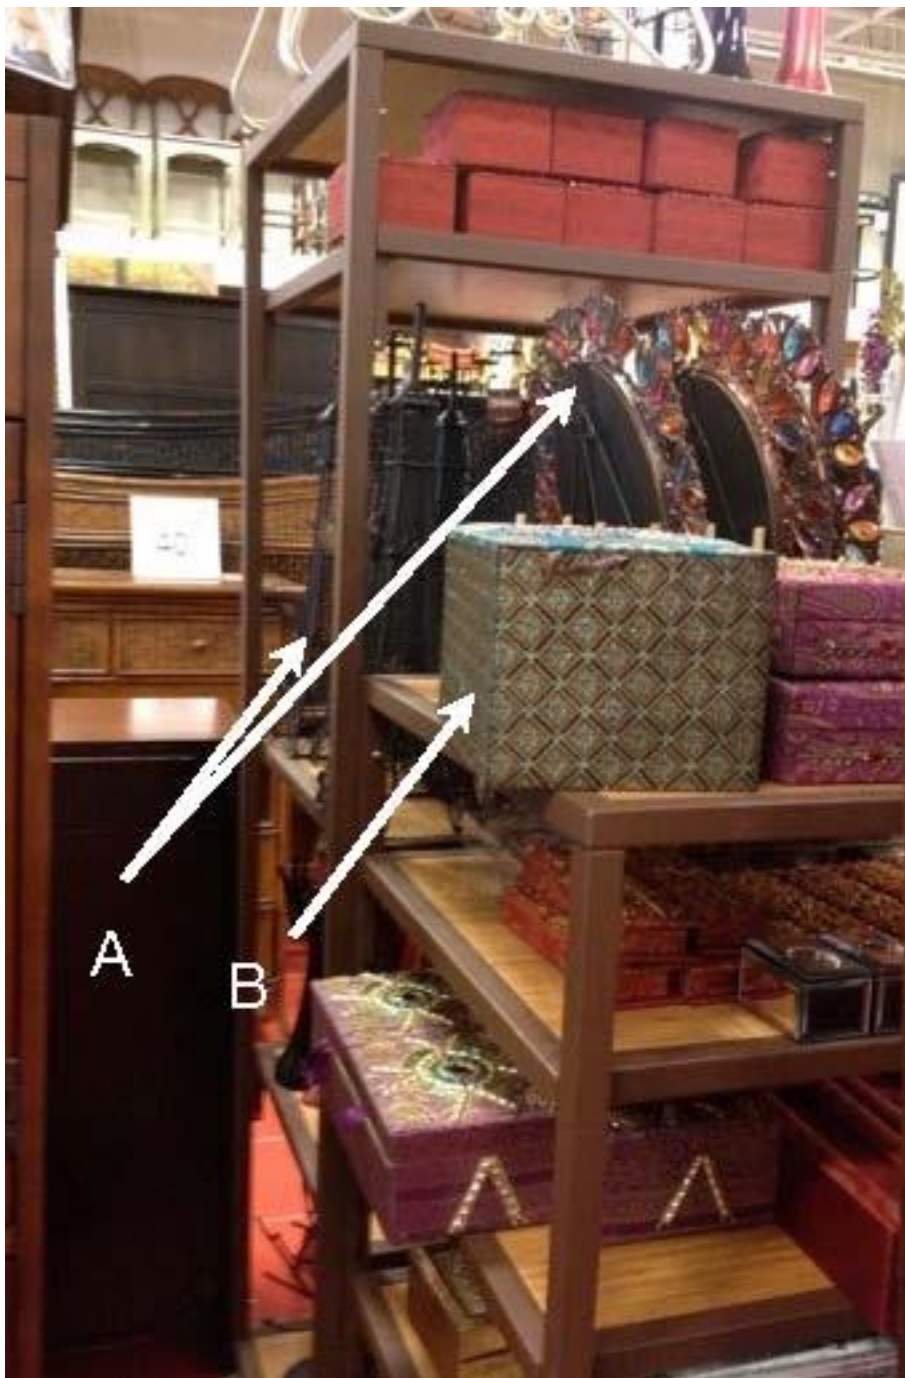
A. The shelf unit is filled with product and represents the fact that the correct way to show product when going vertical is to have supporting levels for all items being shown. In reviewing this product presentation I question the stability of the mirrors. I realize that the nature of an easel stand is not the most stable method of support but at least the mirrors are set back and not easily disrupted.

B. The boxed shape item is leaning over the edge of the shelf. At some point if it is not put back onto the shelf correctly it might be a potential hazard.

In summary, when you have so many irregular shape objects on display with so many customers handling these items some procedure should be in place to avoid unsafe conditions.

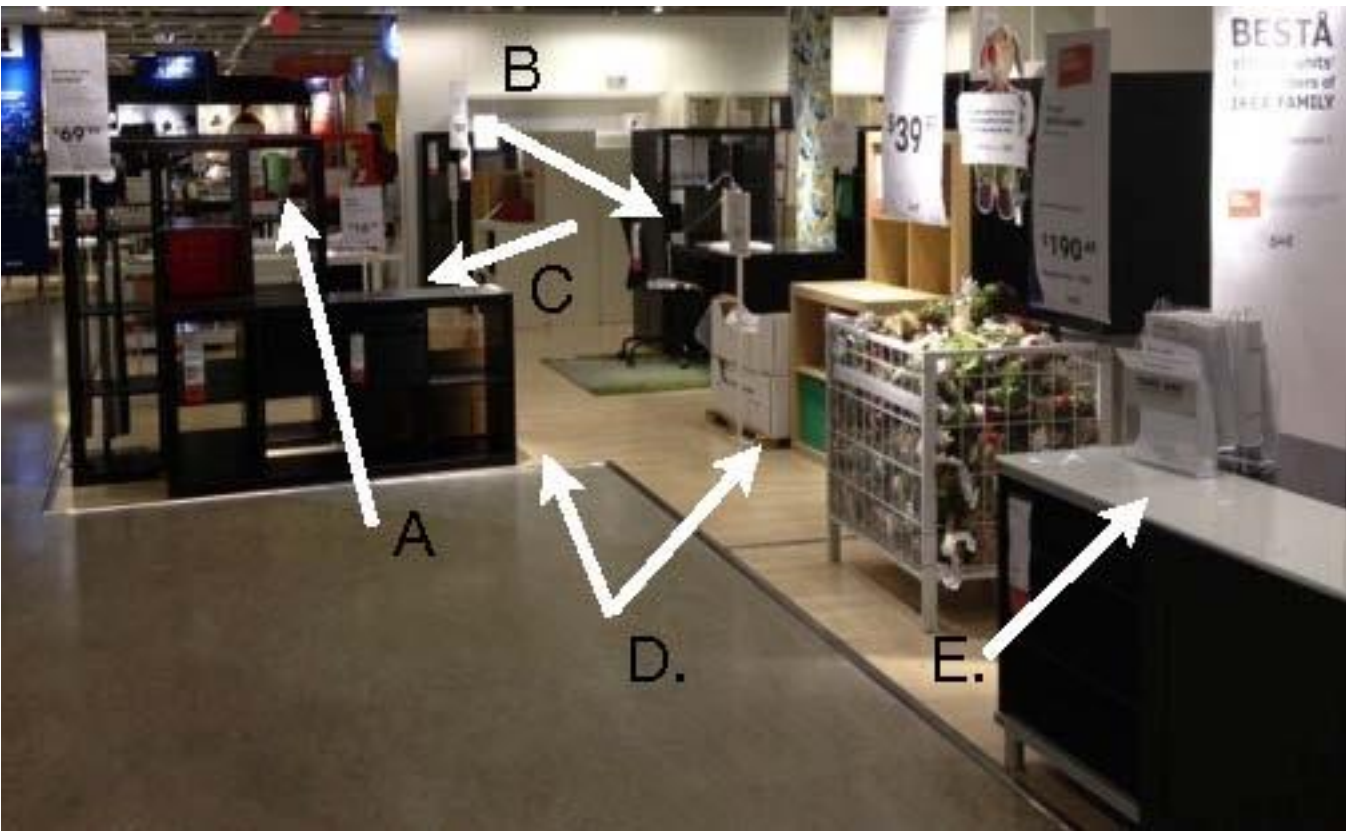
- D. A critical decision was made for this store to build a store sized correctly and safely for the product inventory desired to show. Furniture Retail Store took a less methodical approach to designing their store. It appears that Furniture Retail Store has a philosophy of merchandising that accepts encroaching on the aisle widths and overloading the surface areas of furniture with an abundance of accessories. The end result of the Furniture Retail Store lack of sales floor space has created unsafe conditions for customers.
- E. This is another example of a surface area that could have been easily filled with accessories, however there is a risk of placing product in harms way when exposed.
