## Elements of Failure Analysis

Wayne Reitz, PhD, PE  
Reitz Consulting, Ltd  
96 Meadowlark Lane  
Fargo, ND 58102  
701 235 0859 (w) 701 235 6122 (f)  
[wreitz@reitzmetallurgy.com](mailto:wreitz@reitzmetallurgy.com)  
[www.reitzmetallurgy.com](http://www.reitzmetallurgy.com)

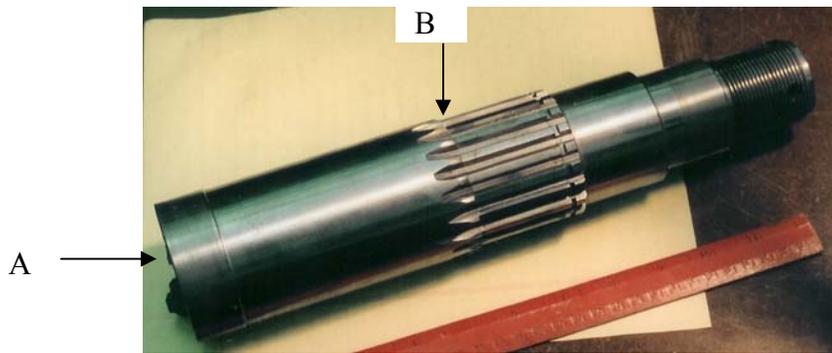
Figure 1. Axle from skid-steer earth mover. Failure occurred at locations A and B.

Fatigue indications include ratchet marks and beach marks that are visible at 1X. SEM inspection can show striations at high magnification. Fatigue is influenced by notches, scratches, and transition areas where diameter changes occur. Figures 1- 4 show some typical fatigue features.

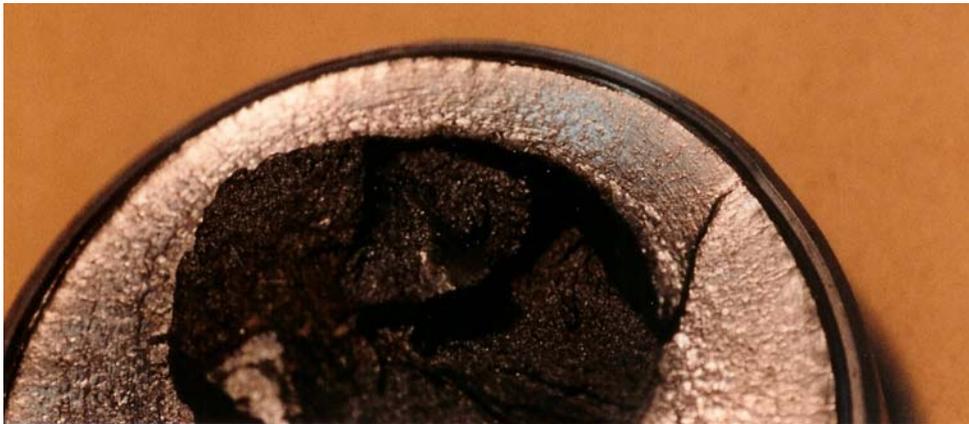
Figure 2. Failure at location "A". Beach marks are present on fractured surface.

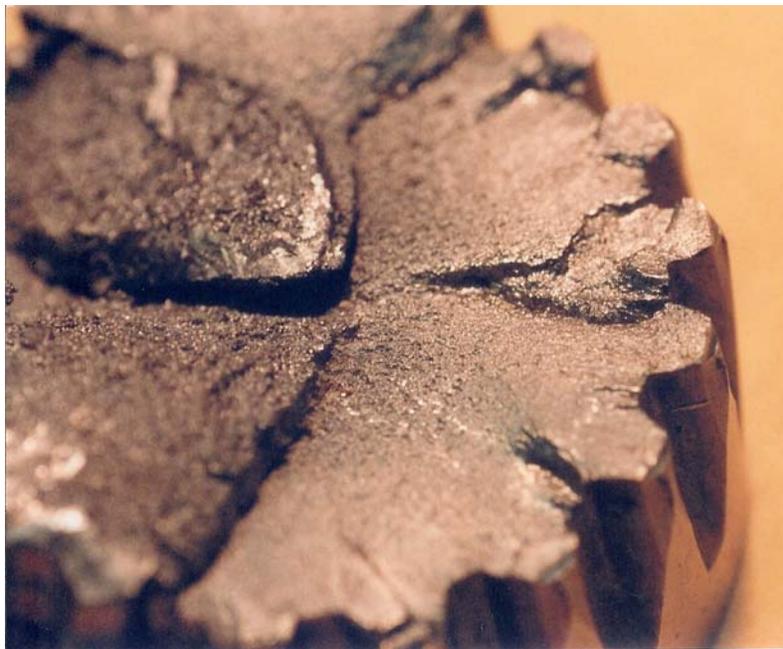
Figure 3. Failure at location "B". Note ratchet marks at spline roots.

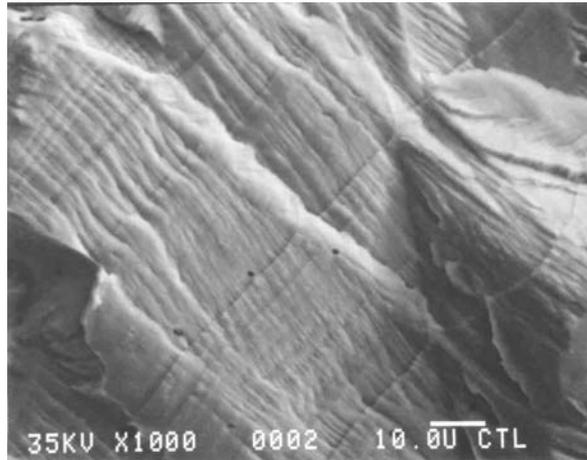
Figure 4. Typical striations.

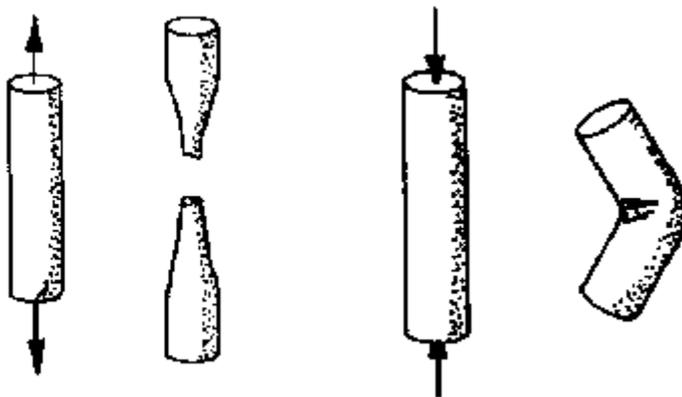
Figure 4. Typical forms of axial overload.

Signs of plastic deformation or fractured planes perpendicular to the applied tensile forces are indicative of this type failure. Figure 4 shows some typical tensile and compression failures.

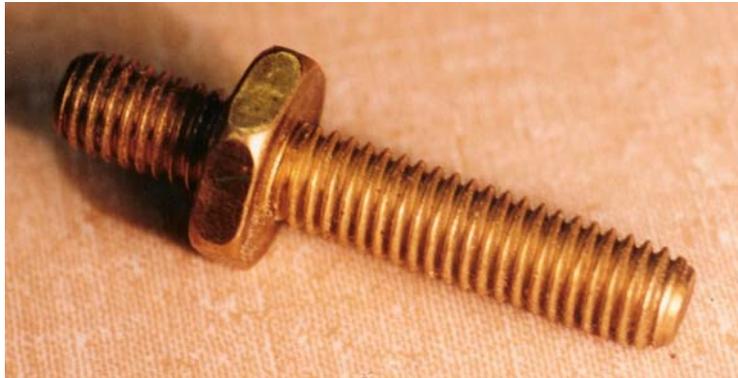
Figure 7. Brass Bolt.

Fracture surfaces contain many features that help the failure analyst determine the root cause of failure.<sup>(4, 5, 6, 7, 20)</sup> Inscribed marble slabs were falling off the front of a mausoleum. Some of the slabs were 20 feet in the air; fortunately nobody was injured. The slabs were held in place with brass bolts that did not have any loads from the marble slab; the entire weight was supported by other hardware. Yet, it was these brass bolts that were failing, which merely kept the marble slabs vertical. Figures 7 - 9 depict the failed

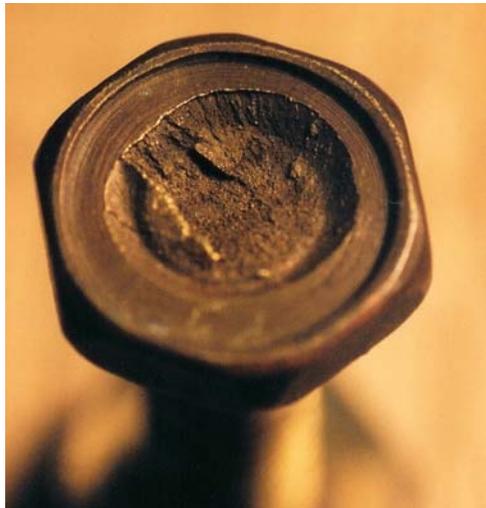
Figure 8. Failure of Brass bolt.

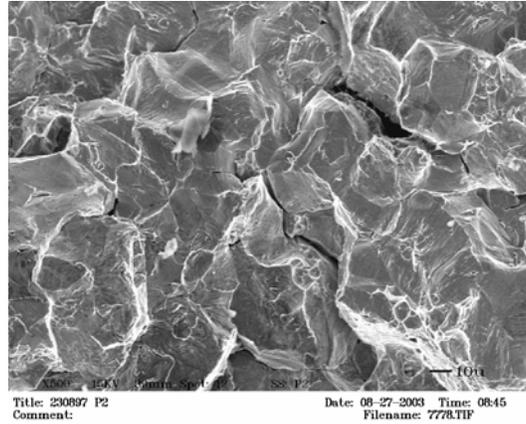
Figure 9. SCC of failed brass bolt.

bolts. Results of the examination showed that SCC had occurred as shown in Figure 9. The bolts were exposed to ammonium via fertilizer, which brass is susceptible to. The source of stress was puzzling. Visiting the site and watching the removal of bolts that would be analyzed, revealed the high levels of torque used during the installation. Residual stress was present due to the heading operation, which was not followed by an anneal. Details of this failure can be found elsewhere.<sup>(21)</sup> If one of the three criteria for SCC had been removed ( 1] presence of stress, 2] corrosive environment, and 3] susceptible material ), then these failures could have been prevented.

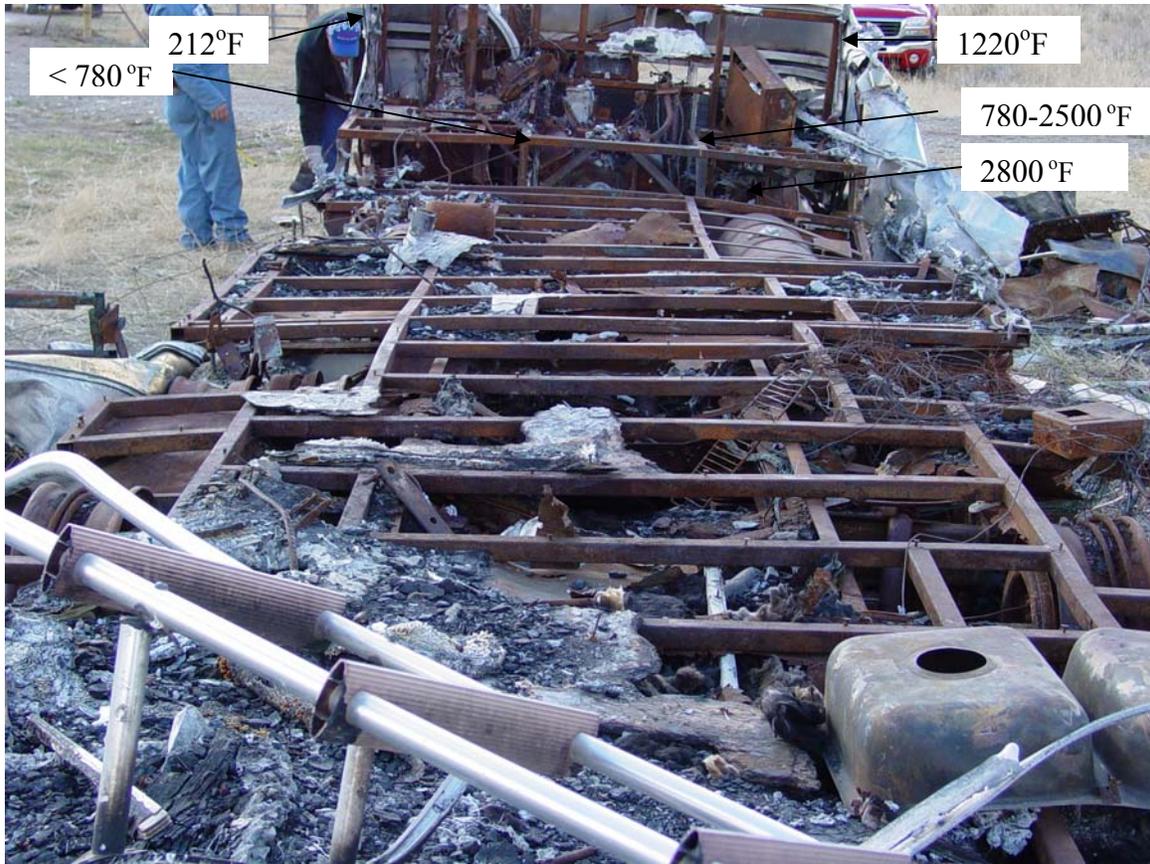
Figure 10. Temperature profile of engine area.

The approach in this case was to use metallurgical knowledge of melting temperatures and phase diagrams <sup>(8)</sup> to show the temperatures experienced in various locations throughout the RV. By examining the surface of various metals (steel, copper, and aluminum) located in the engine compartment, the temperatures could be bracketed. Melting of aluminum ( $T_M = 1220^\circ\text{F}$ ,  $660^\circ\text{C}$ ) dripped onto copper tubing. Copper melts at  $1985^\circ\text{F}$  ( $1085^\circ\text{C}$ ), whereas eutectic melting of Cu + Al can occur as low as  $1018^\circ\text{F}$  ( $548^\circ\text{C}$ ). Examination of various components retrieved from the RV was conducted and Figure 10 shows the results of this analysis.

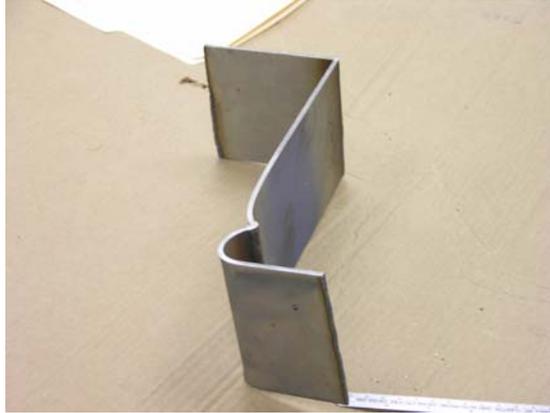
Figure 11. Successfully welded component; ductile weld.

A manufacturing company was having difficulty with cracking in their welds on stainless steel (Ferritic SS with austenitic filler metal). They submitted four samples with different weld parameters for metallurgical evaluation that consisted of microstructure and microhardness testing. Knowledge of microstructures is essential to understanding the relationship between processing, alloy, performance, and structure.<sup>(21)</sup> Figures 11 - 14 show the some of the samples and results. Some of the conclusions were: 1) Cool the weldments at a faster rate, perhaps by using a backplate to prevent sensitization and formation of Martensite, 2) Employ a cover gas for the top and bottom of the weld to minimize Nitrogen pickup and the ensuing formation of Martensite, and 3) Develop a consistent bend test to characterize the ductility of the welds.

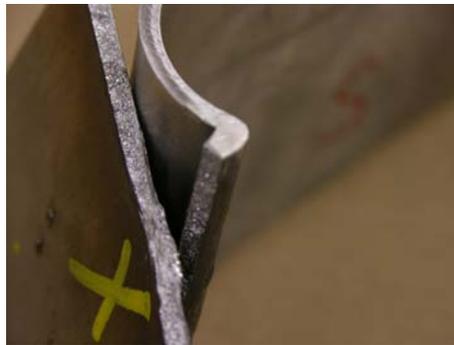
Figure 12. Failed weld; no ductility.

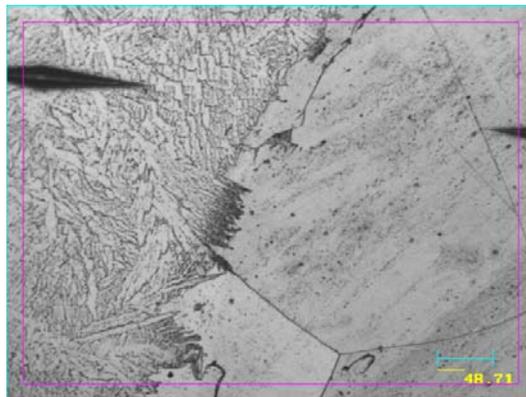
Figure 13. Microstructure of fusion zone and base metal that exhibits grain growth. Good interface between these two zones.

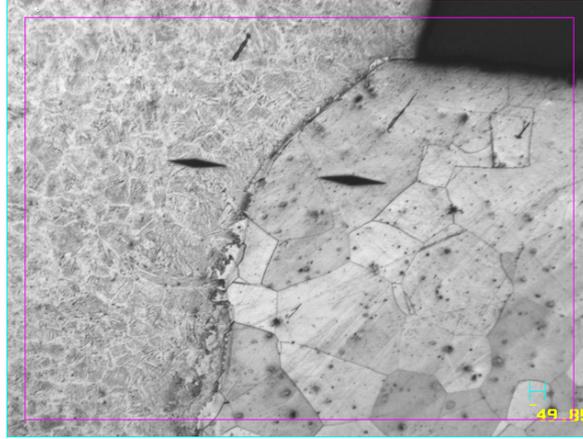
Figure 14. Microstructure of fusion zone and base metal. Note poor interface quality. Diamond shapes are microhardness indentations.
