Failure Investigation &
 Premises Defects Claims

Professional

Inspection

Consultants

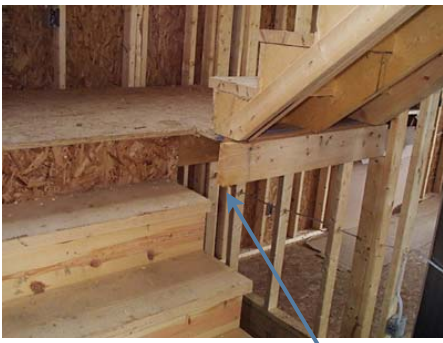
Q: What's holding up this stairway?

A: Actually, almost nothing. This may very well have resulted in failure and injury, potentially serious.

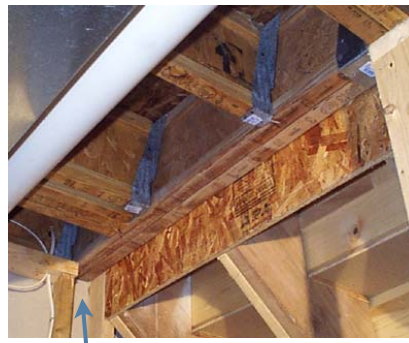
Q: What's holding up the living room?

A: The drywall. The TJ floor joists from the left, including the multiple 'gang' joist carrying a concentrated wall load from above, form the living room floor. They are attached improperly to the header at the top of the stairs with a single joist hanger, not a beam hanger, and without the required web fillers. Notice above the indicator that the double wall plate stops. This header carrying the floor loads, wall loads from above as well as the stair load transfers all of its weight to the drywall! This would have resulted in a catastrophic collapse. It was inspected and passed!

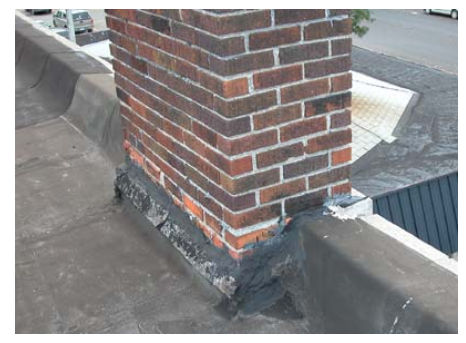
Q: What's wrong? More than just bad flashing at the chimney.

A: The raised parapet wall is a required fire break intended to stop fire spreading to the adjacent building or property. Combustible roofing may not be lapped up over it.
